Manhole Inspection Summary

Manhole # S51Q__001MH

Insp Date: **3/17/09 12:49 PM**

Location Address: **2900 LINWOOD AV**

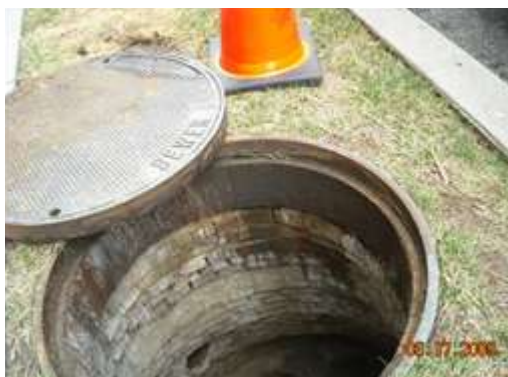
MISC.

Subject To Ponding: **Sheeting**

INFLOW EVIDENCE FROM SHEETING

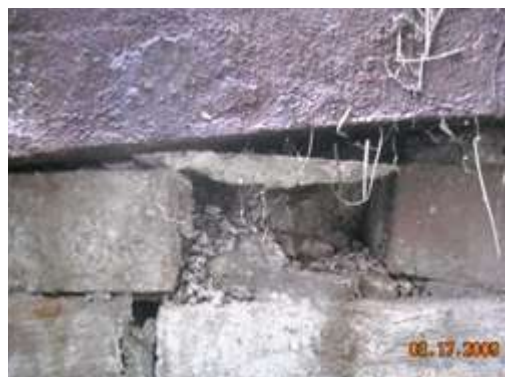
Defect 2

Condition: ☐ Sound ☐ Cracked ☐ Root Intrusion ☒ **Loose Brick** ☒ **Deteriorated**

DETERIORATED CHIMNEY; SPIDER WEBS, NO ROOT INTRUSION

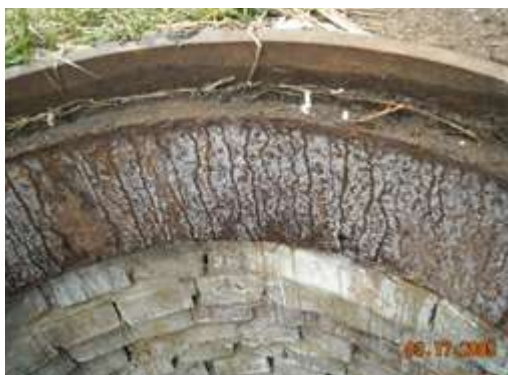
Defect 1

☒ **Leaks**

FRAME LEAKS

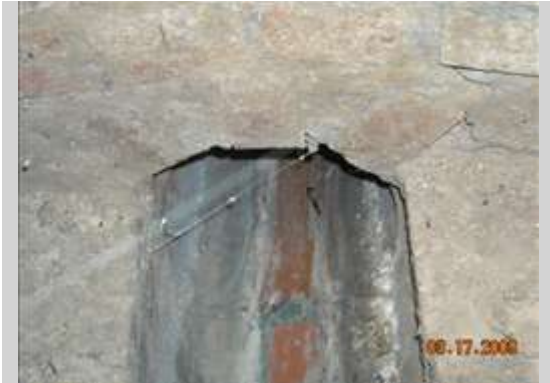
12 O'Clock Outflow

8 in. Circular Gravity Sewer
Pipe Out @ 12 O'Clock

Pipe Height: **8.4** (in.) Rod and Bar (Angled)
Pipe Material: **Clay** ☐ Pipe Lined
Invert Depth: **6.80** (ft.) Flow Characteristics: **Slow**
Deposits: ☒ None ☐ Mud ☐ Sludge ☐ Debris ☐ Grease
Silt Depth: **0** (in.) Deposits Extent:
Infiltration: **None** Pipe Seal Cond: **Sound**

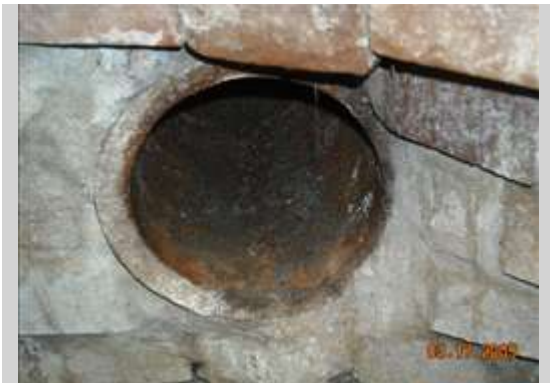
5 O'Clock Inflow

6 in. Circular Gravity Sewer
Pipe In @ 5 O'Clock

Pipe Height: **6** (in.) Rod and Bar (Angled)
Pipe Material: **Clay** ☐ Pipe Lined
Invert Depth: **4.55** (ft.) Flow Characteristics: **None**
Deposits: ☒ None ☐ Mud ☐ Sludge ☐ Debris ☐ Grease
Silt Depth: **0** (in.) Deposits Extent:
Infiltration: **None** Pipe Seal Cond: **Sound**

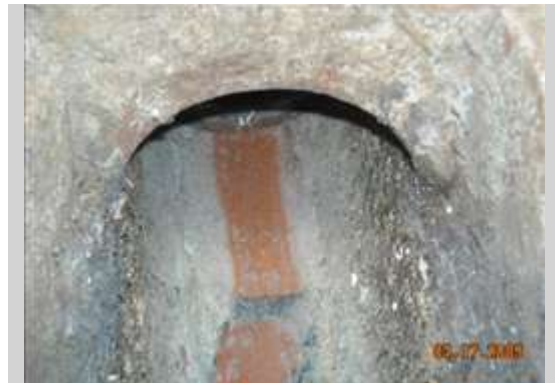
Drop In @ 5 O'Clock

Drop: **Outside** Rod and Bar
Angled: **Yes** Reading: **5.50** (ft.)
Inv Depth: **6.50** (ft.)
Drop Condition: **Open**

Connects To: **House connection / Service line**
